Imaging-based In-Line Surface Defect Inspection for Bar Rolling

Howard (Hsun-hau) Huang, Engineer
Daniel Gutches, Engineer
Tzyy-Shuh Chang, Ph.D., Chief Technical Officer

OG Technologies, Inc.
4300 Varsity Drive, Suite C
Ann Arbor, MI 48108
U.S.A.
734-973-7500 (Voice)
734-973-1966 (Fax)
Chang@ogtechnologies.com
WWW.OGTECHNOLOGIES.COM

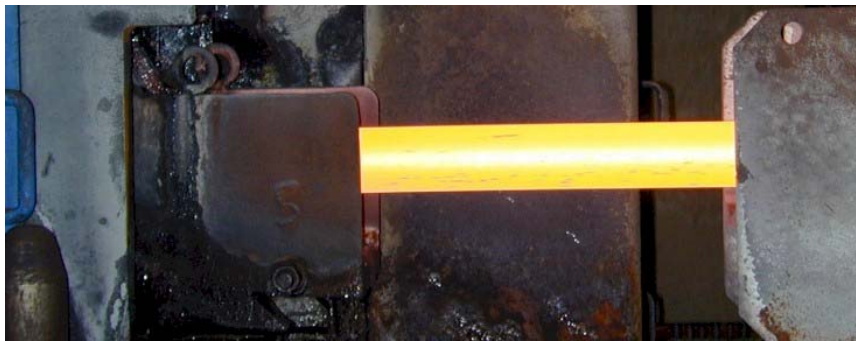
FIGURE 1. HOT ROLLED BAR IN PROCESS.

The rolling mill environment is not friendly, either. The surface temperature of hot rolled bars may be as hot as 1,100 °C. Along with the semi-continuous rolling process, the hot bar will emit significant amounts of heat radiation to the surrounding area and equipment. The bar can flutter significantly when traveling at a high speed. The magnitude of flutter can be even larger than the product diameter itself for small diameter wire rods. In addition, the bar rotates/twists as it is rolled. For high-speed mills, bars are well confined in a series of guides (to prevent the high speed, high temperature bars from cobbling), leaving little space for image acquisition equipment. Water and debris is another concern for the imaging systems along the rolling line. Figure 1 gives a view of a hot rolled bar in process.

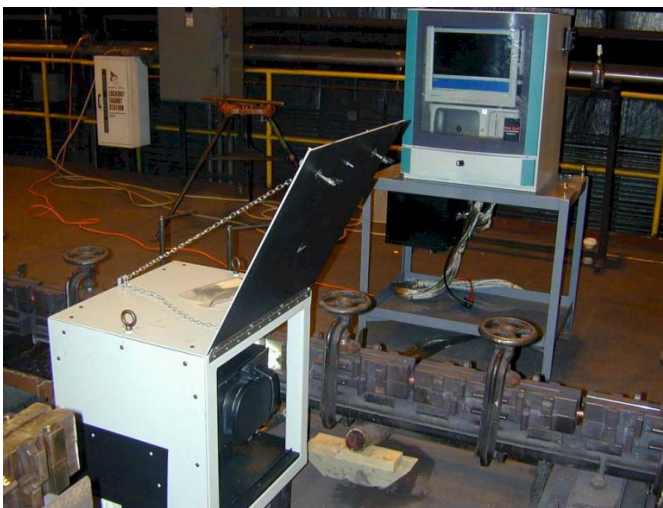
FIGURE 3. ALPHA HOTEYE™ SYSTEM.

With the interest and support from the steel industry combined with the support from the US federal government, an Alpha system and two Beta systems were delivered for rod and bar mills. The Alpha system, shown in Figure 3, was installed at Charter Steel (Saukville, WI) in June 2002. The system is limited in that it inspects less than one quarter of the bar surface, and requires frequent manual adjustments.

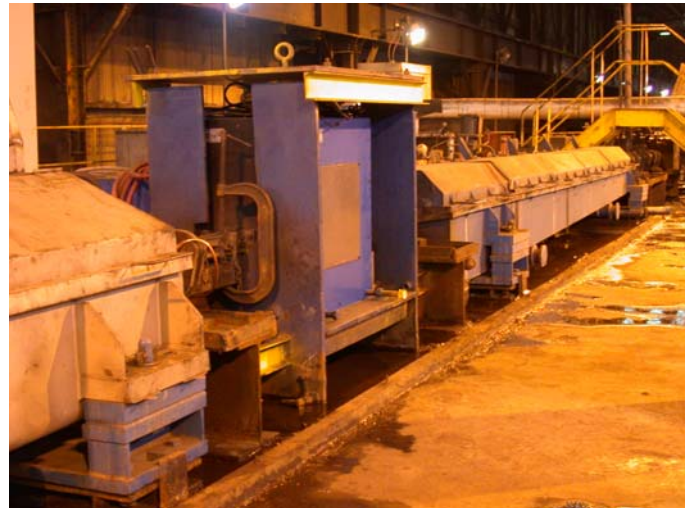
FIGURE 4. BETA HOTEYE™ SYSTEM FOR ROD MILLS.

The Beta system for rod mills was installed at Inland Steel (East Chicago, IN) in December 2003, as shown in Figure 4. This is a full system. It is capable of inspecting the entire surface of a steel bar. The bar diameters can be from 9.525 mm (0.375”) to 38.1 mm (1.5”).

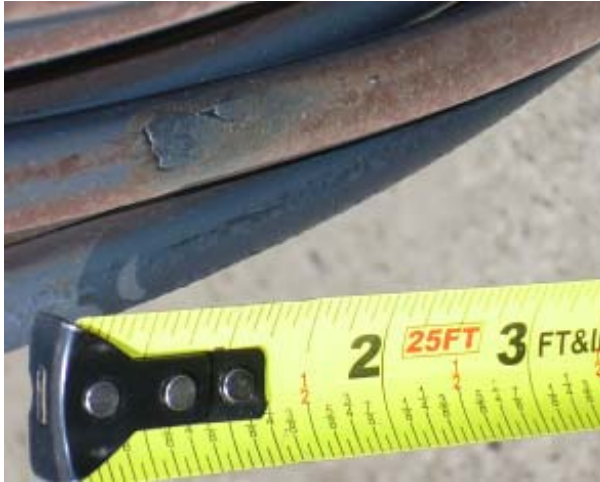
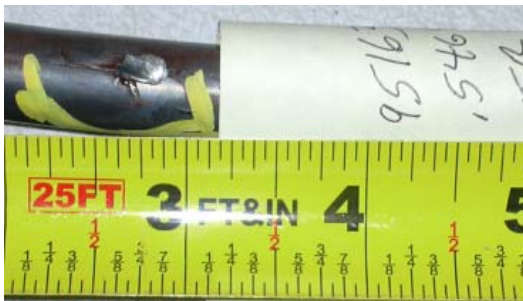
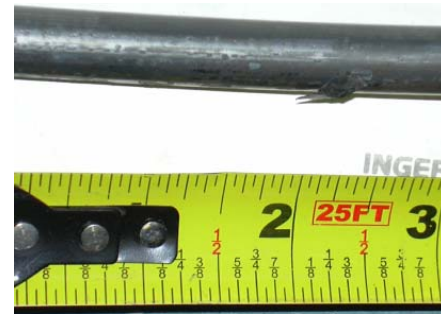
Top left: a series of severe shearing defects

Bottom left: a thick scab pulled back from the steel surface, but still attached to the base material.

Bottom right: a thin sliver peeled off from the steel surface and still attached to the base material

FIGURE 12. SHEARING AND SCAB MARKS DETECTED HOTEYE™.

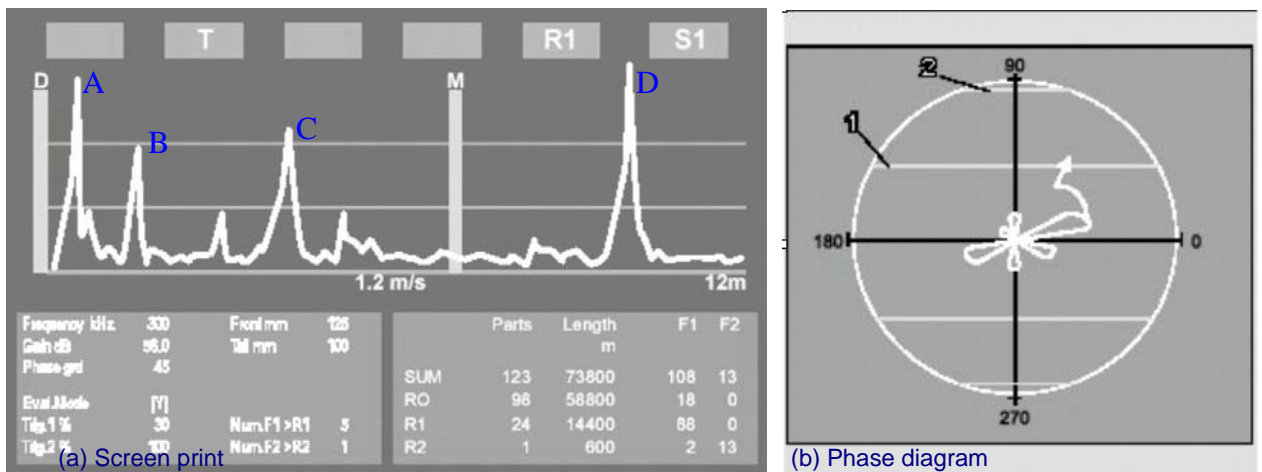
FIGURE 22. EDDY CURRENT REPORT.

The most significant difference between an imaging system and an eddy-current system is in data depth. The imaging system provides an additional dimension in data, allowing a better detection accuracy and improving the utility of the data in effective process control. A screen print of an eddy current report is shown in Figure 22. Although the intensity of the signal is supposed to indicate defects, there is no intuitive interpretation as to what these indications represent. There is no answer as to whether they (peaks A and B, for example) are similar defects or not, or even whether they are true defects or not. The phase diagram does extend the data space beyond one-dimensional, and therefore, intuitive answers are not readily available from the diagram either. The bottom line is, there is no additional information to verify and evaluate the eddy current output.
